PLEASURE LAKE DAM
SULLIVAN COUNTY, NEW YORK
INVENTORY NO. 345

PHASE I INSPECTION REPORT
NATIONAL DAM SAFETY PROGRAM

SEPTEMBER 1978

DELAWARE RIVER BASIN
PLEASURE LAKE DAM
INVENTORY NO. 345
PHASE I INSPECTION REPORT

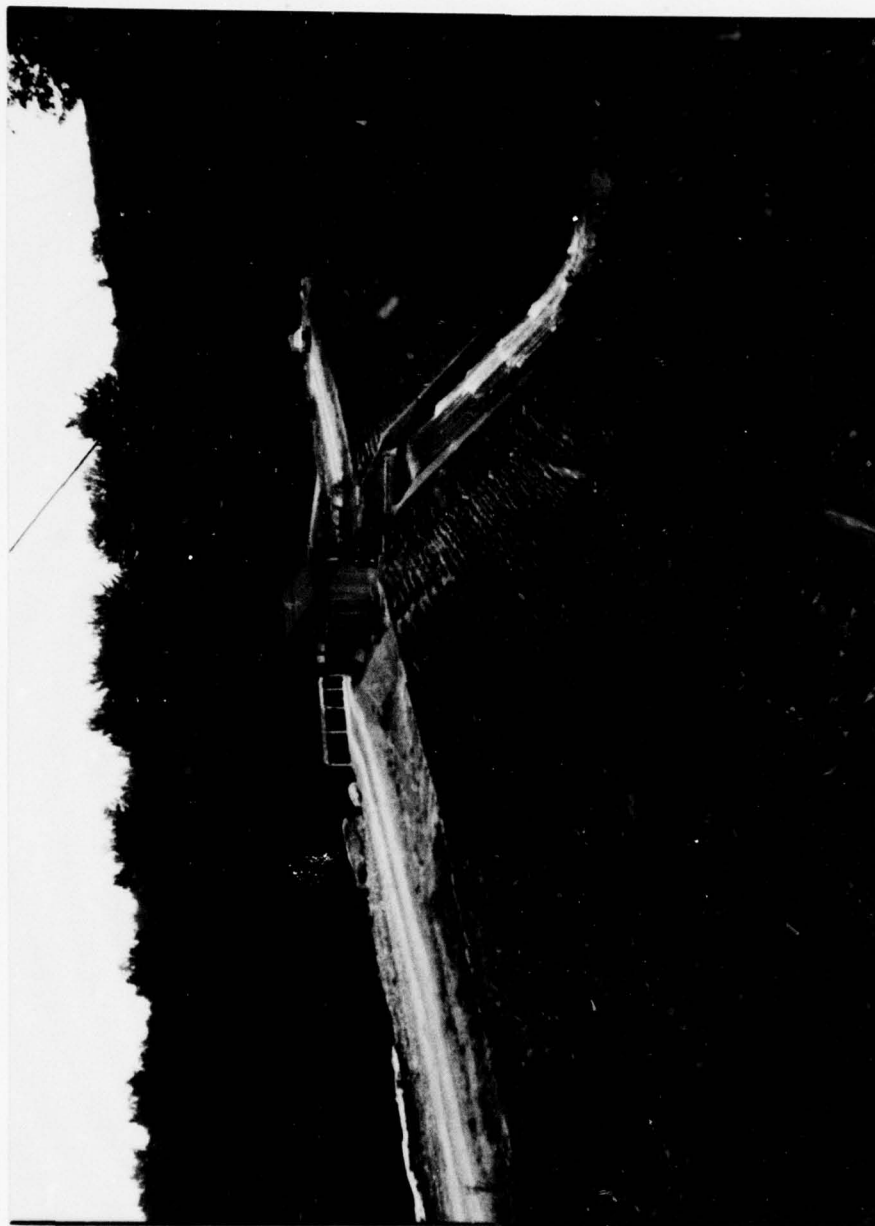
1) GENERAL OVERVIEW OF MASONRY - EARTHFILL DAM AND SPILLWAY

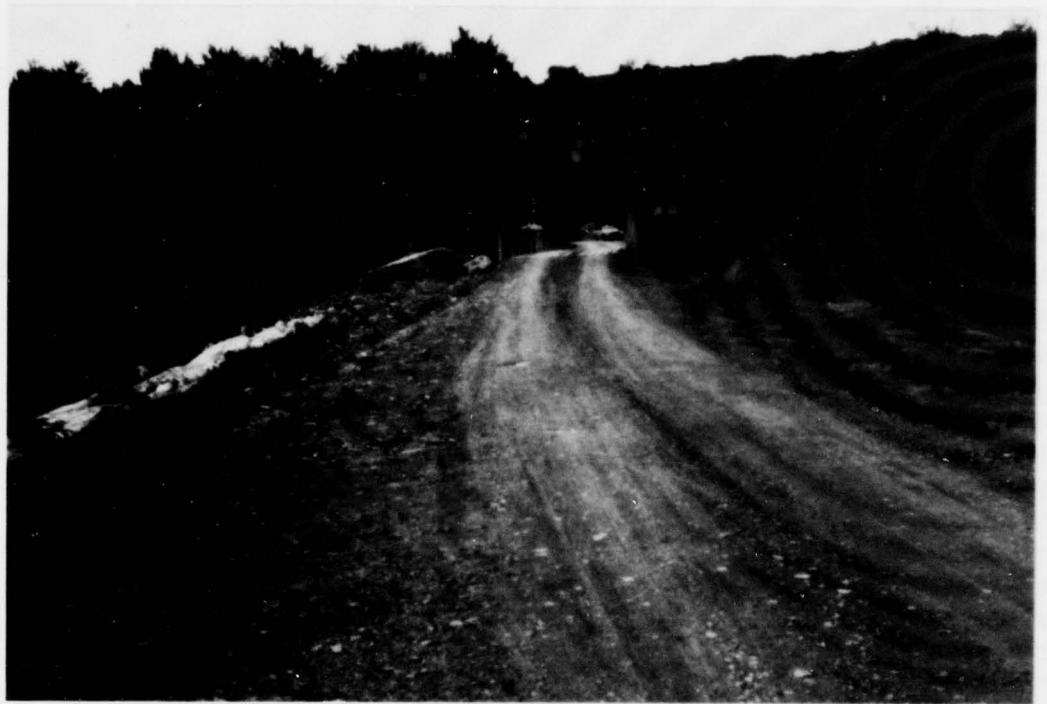
Crest alignment is generally good with only a few depressions created by traffic. An overlay of 65 tons of crushed rock rolled on to the crest road about 10 weeks before the inspection elevates only the road surface about 6 to 12 inches. The horizontal and vertical alignment of the embankment were good. It was observed that the downstream edge of the masonry crest, east of the gatehouse shows some curvature; however, no recent movement is apparent.

A longitudinal crack about 20 feet long is located on the crest, about two feet upstream of the roadway edge and approximately 40 feet west of the bridge. The crack appears to be caused by settlement of the fill placed in 1978.

2) CREST OF DAM LOOKING EAST

- a. The upstream earth slope should be flattened and riprapped. A bedding layer of suitable material should be placed between the earthfill and the riprap. The remainder of the slope should be seeded. The longitudinal crack observed along the upstream slope should be repaired prior to flattening and seeding the slope.

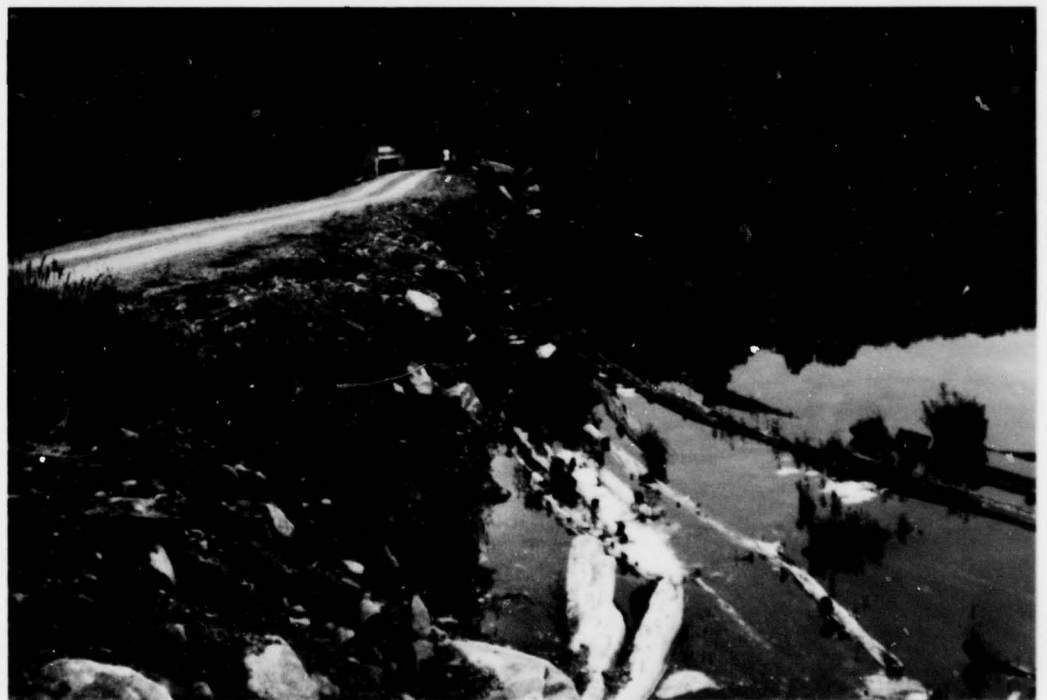
3) UPSTREAM SLOPE LOOKING WEST , NOTE LOGS AT WATERLINE

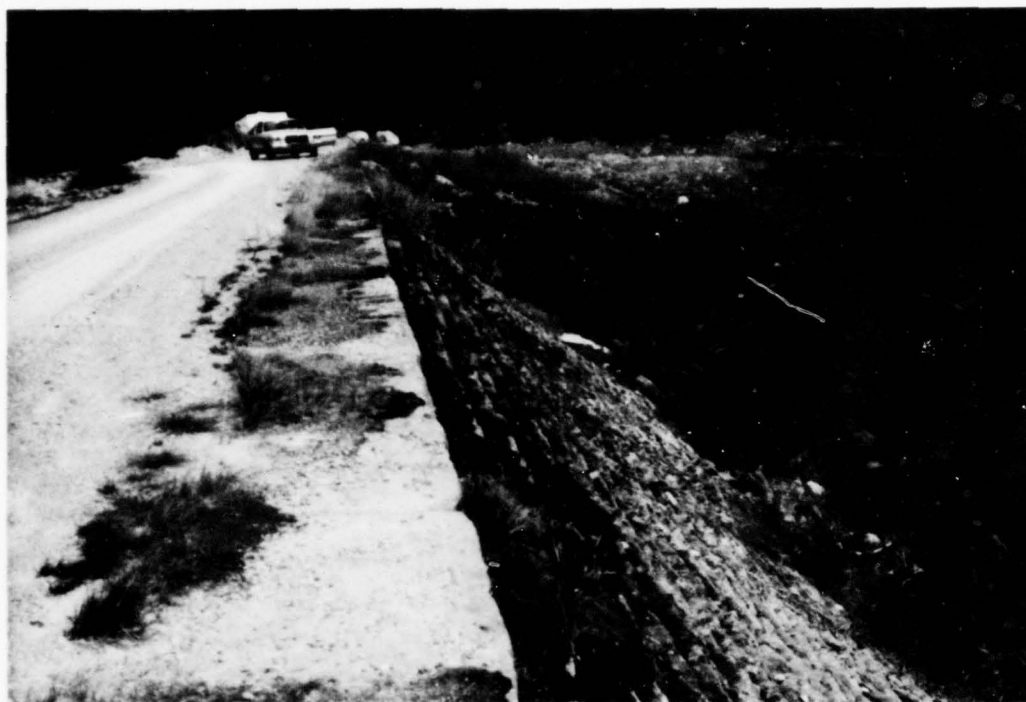
4) DOWNSTREAM SLOPE LOOKING EAST, NOTE AUXILIARY EMERGENCY SPILLWAY TO RIGHT OF AUTO

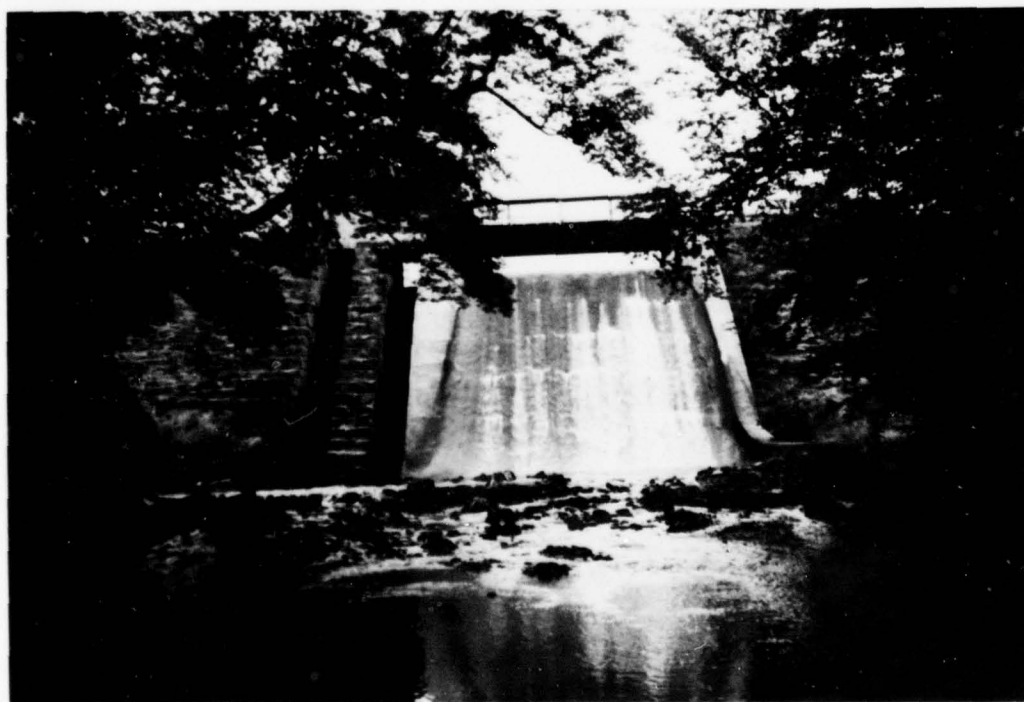
The sluiceways and emergency spillway appear to be in generally fair condition. The approach channels to the sluiceways and emergency spillway are clear of aquatic growth. There was evidence of some minor cracking and some missing pointing along the concrete training wall surfaces. Slight leakage was observed between the masonry and gunite surface on the east wall of the west sluiceway.

5) SPILLWAY AND SLUICEWAYS

- d. The auxiliary emergency spillway should be finish-graded and seeded.
- e. Loose and missing pointing at sluiceways and emergency spillway should be repaired.

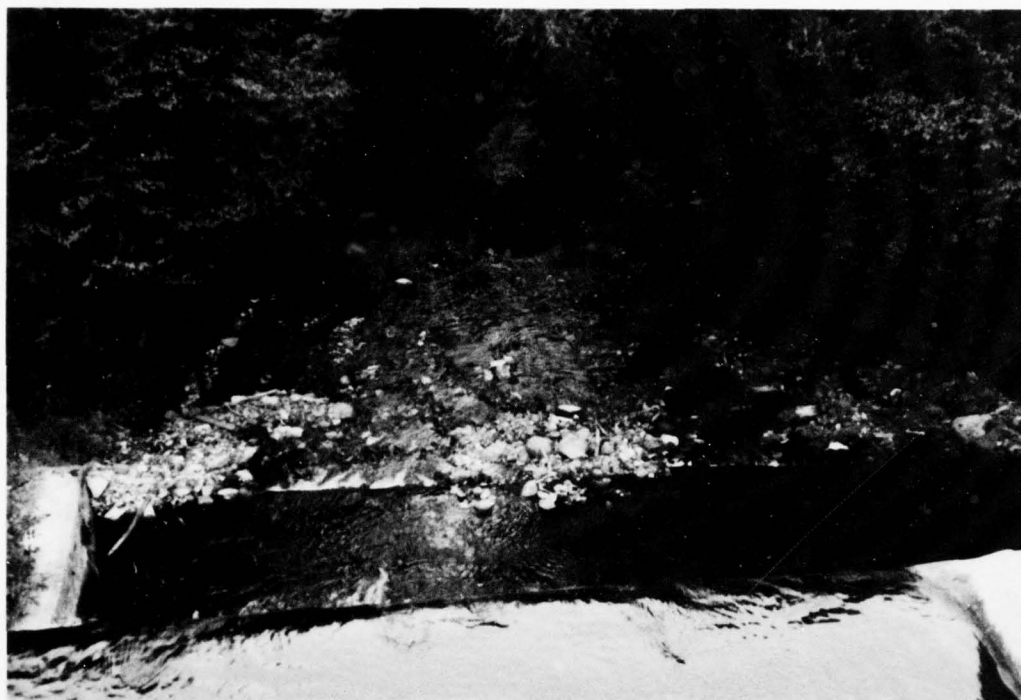
The spillway crest and chute appear to be in good condition. Some minor erosion of the gunite surface is noted. The spillway chute is covered by gunite placed in an overlapped manner.

6) SPILLWAY CHUTE AND DOWNSTREAM CHANNEL

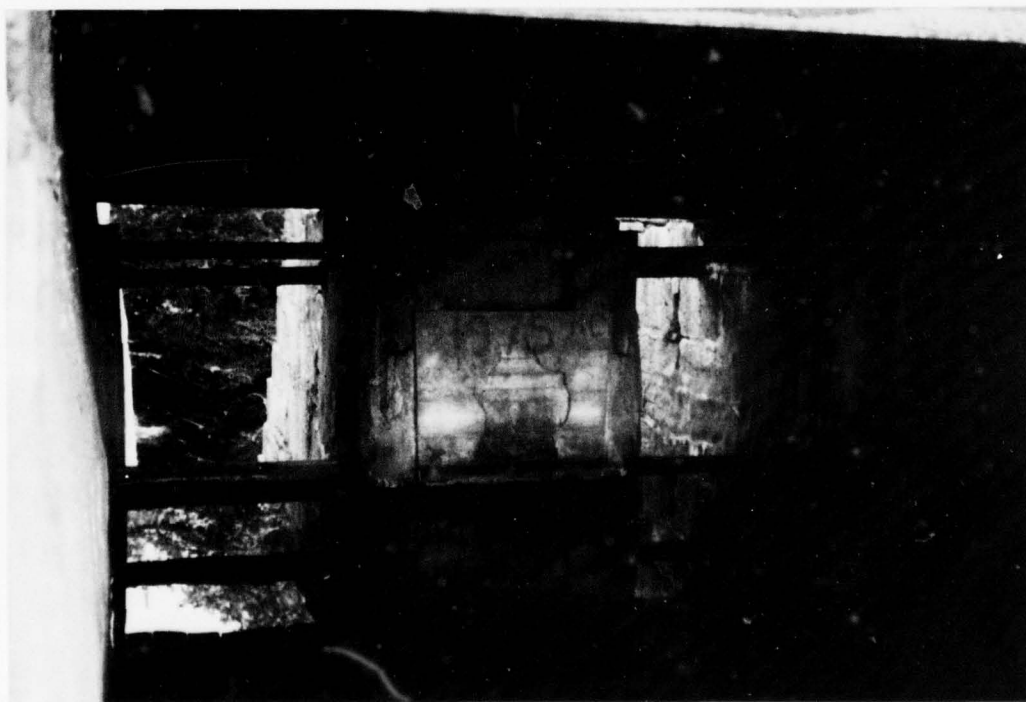
7) APPROACH CHANNEL TO STOPLOG GATES

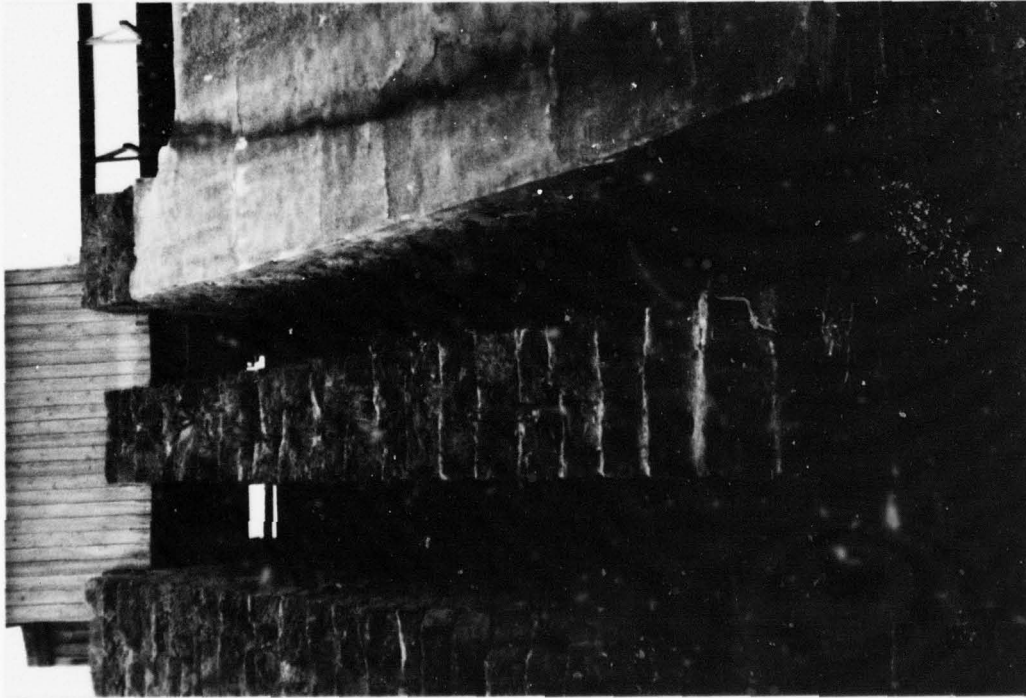
8) SLUICEWAYS

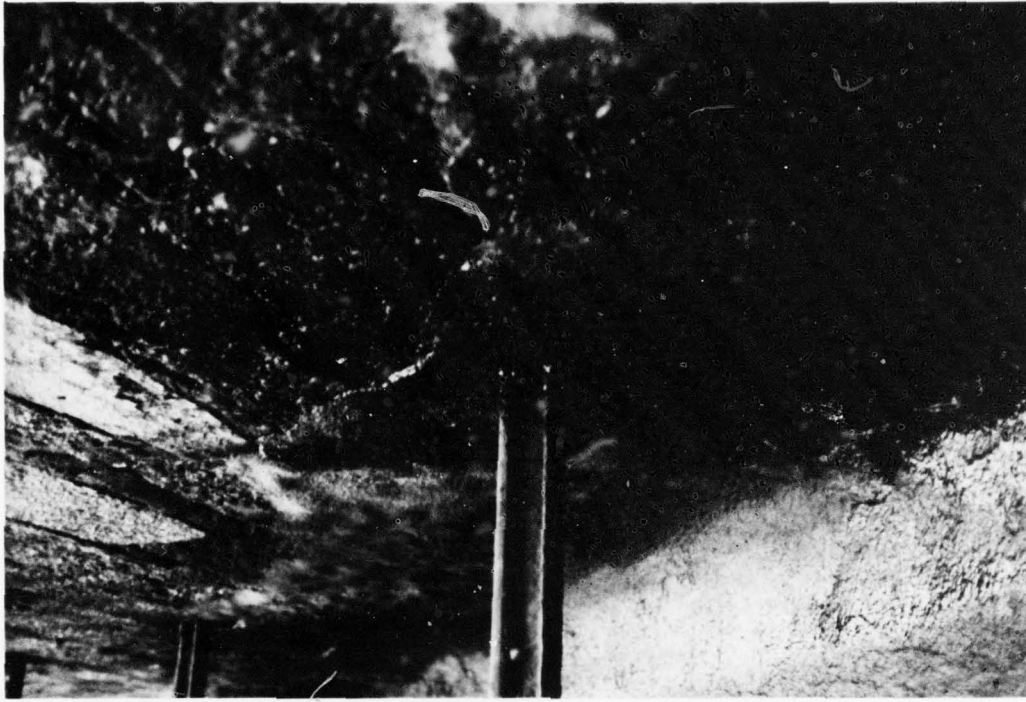
9) EAST WALL OF WEST SLUICEWAY, NOTE LEAKAGE

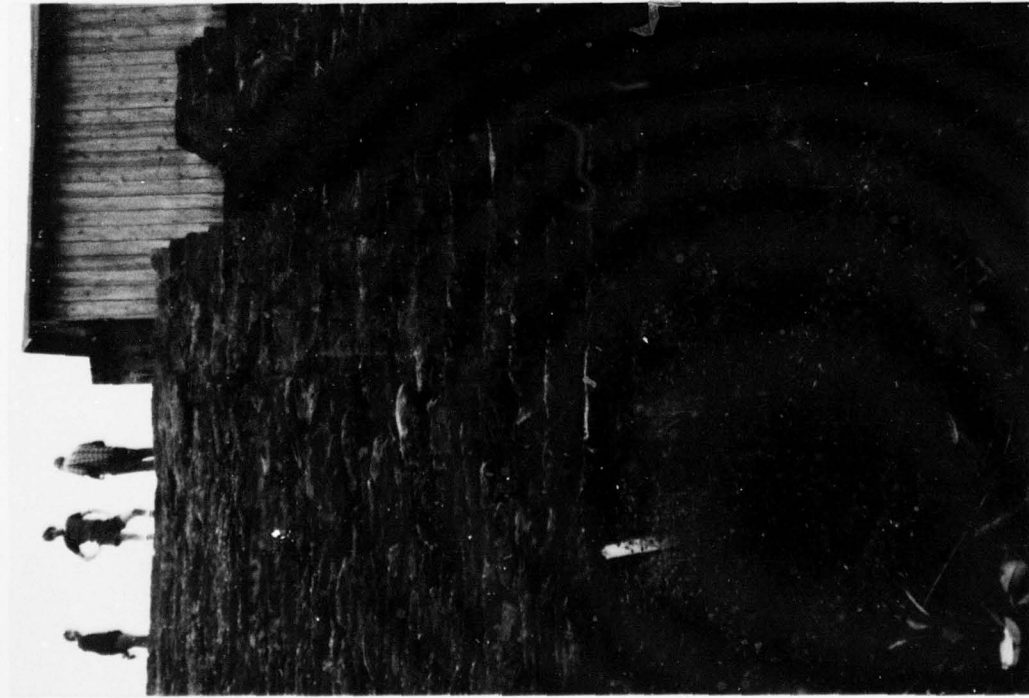
10) ABUTMENT WEST OF SLUICEWAYS, NOTE
VERTICAL SETTLEMENT IN MASONRY

training wall there appears to be a settlement which has caused
a vertical displacement of stones approx 3"

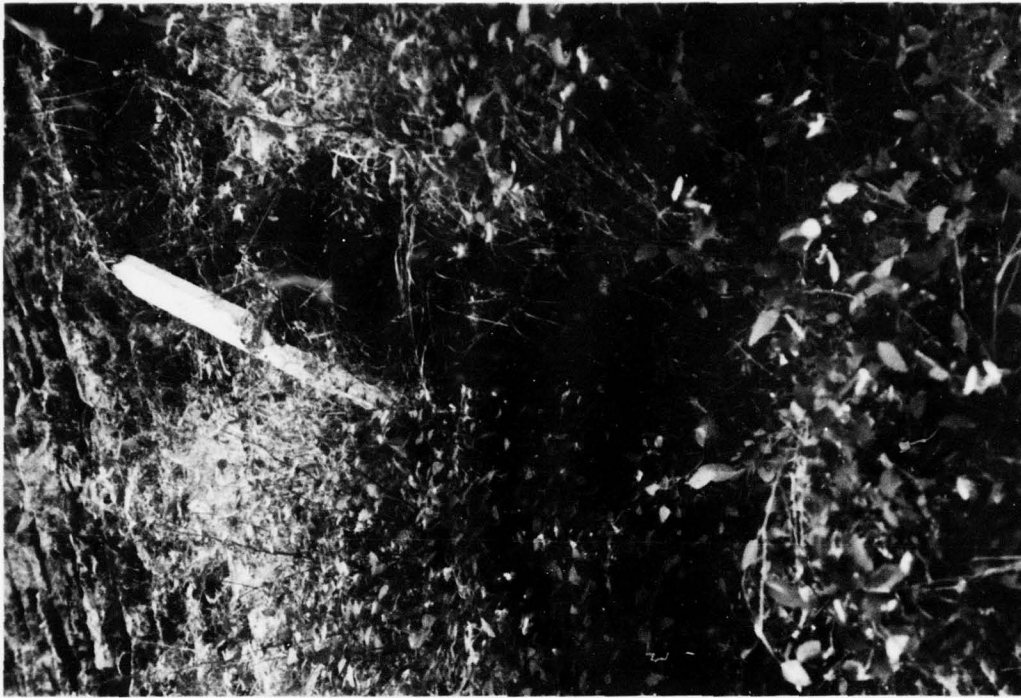
Settlement of the embankment has occurred adjacent to the west sluiceway training wall. Seepage was observed at the toe of the embankment near the location where the settlement occurred. The leakage is estimated at 5+ gpm. The clear water and limonite stained algae growth tend to indicate that the seepage is an old condition. There are several damp areas along the western toe of the dam; however, no visible seepage was visible at these locations. No seepage was observed along the eastern embankment toe.

11) SEEPAGE (IN CENTER OF PHOTO) LOCATED
AT SETTLEMENT NEAR WEST ABUTMENT OF
SLUICEWAYS

Leakage approx 5-10 gpm at right (west) training wall at
toe; water clear; appears old because of lichen-like algae growth.
Several other damp zones at toe, no moving water, may be runoff.

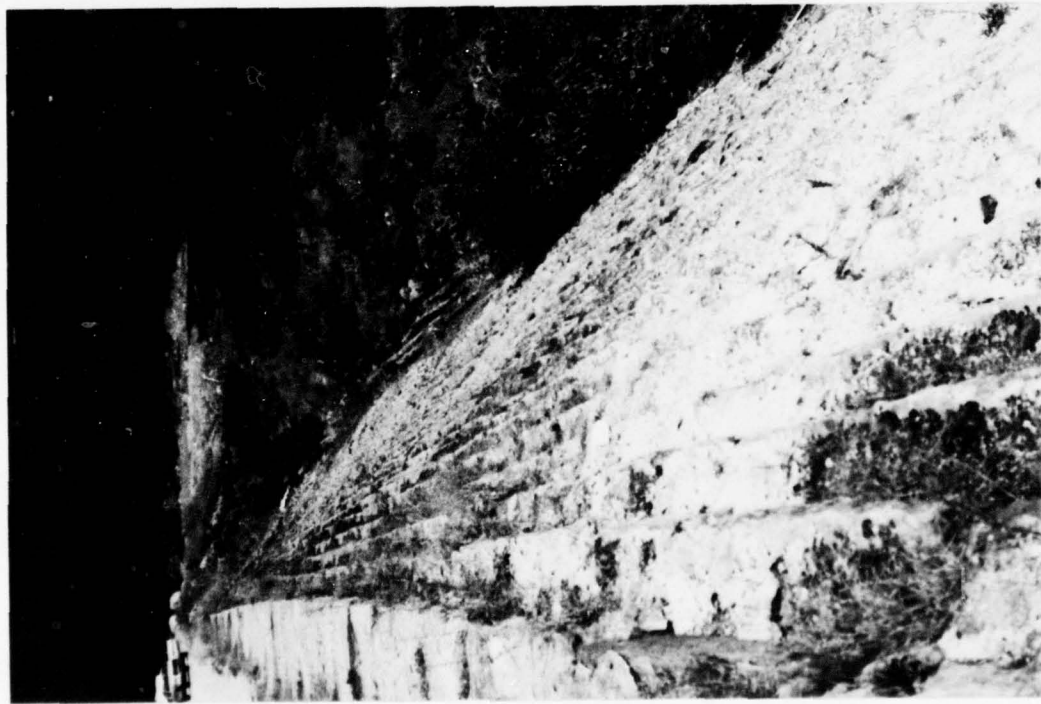
12) DEBRIS AND VEGETATION AT DOWNSTREAM TOE,
NOTE BULGES ON MASONRY FACE ABOVE LOG
PILE AND BUSHES

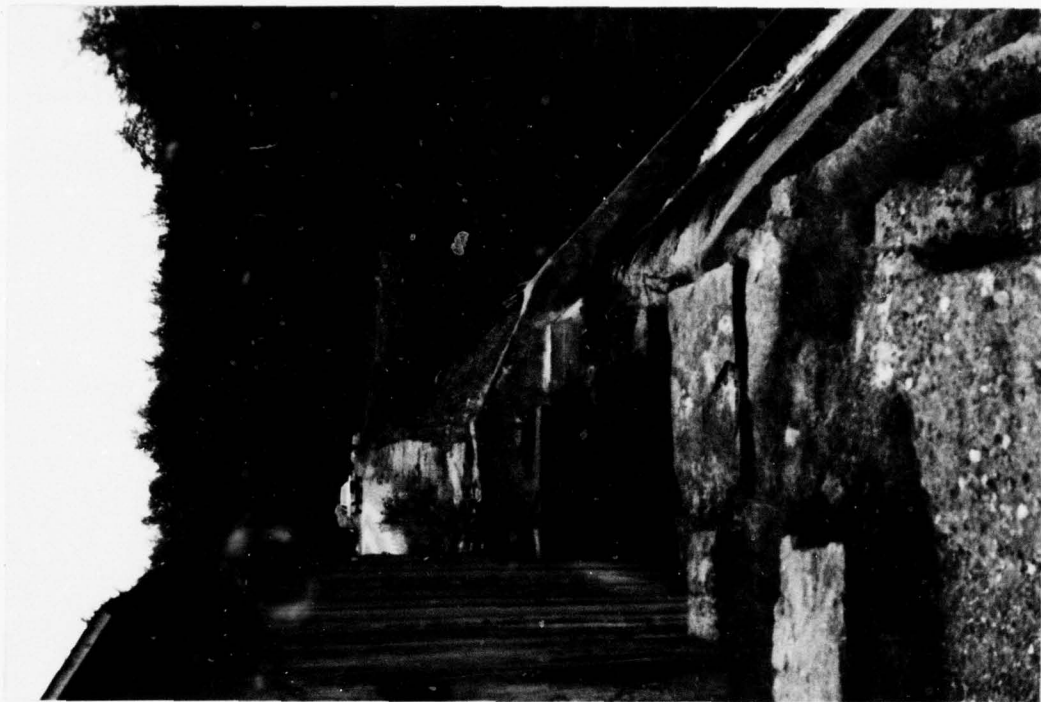
13) EAST VIEW ALONG DOWNSTREAM CREST,
NOTE CURVATURE ALONG CREAT EDGE

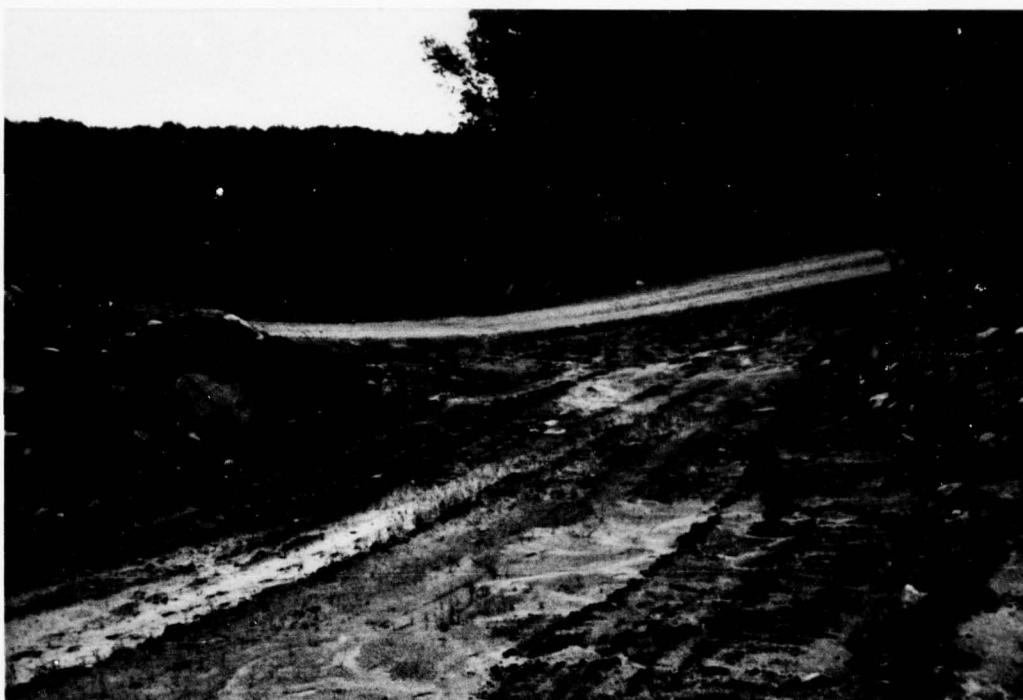
The auxiliary emergency spillway is an unfinished channel cut into natural ground at the east end of the dam. Some minor depressions and erosion gullies from runoff are noted. The gravel crest roadway crosses the channel near its entrance, the road surface being approximately 6 to 8 inches

15) UPSTREAM VIEW OF AUXILIARY EMERGENCY SPILLWAY

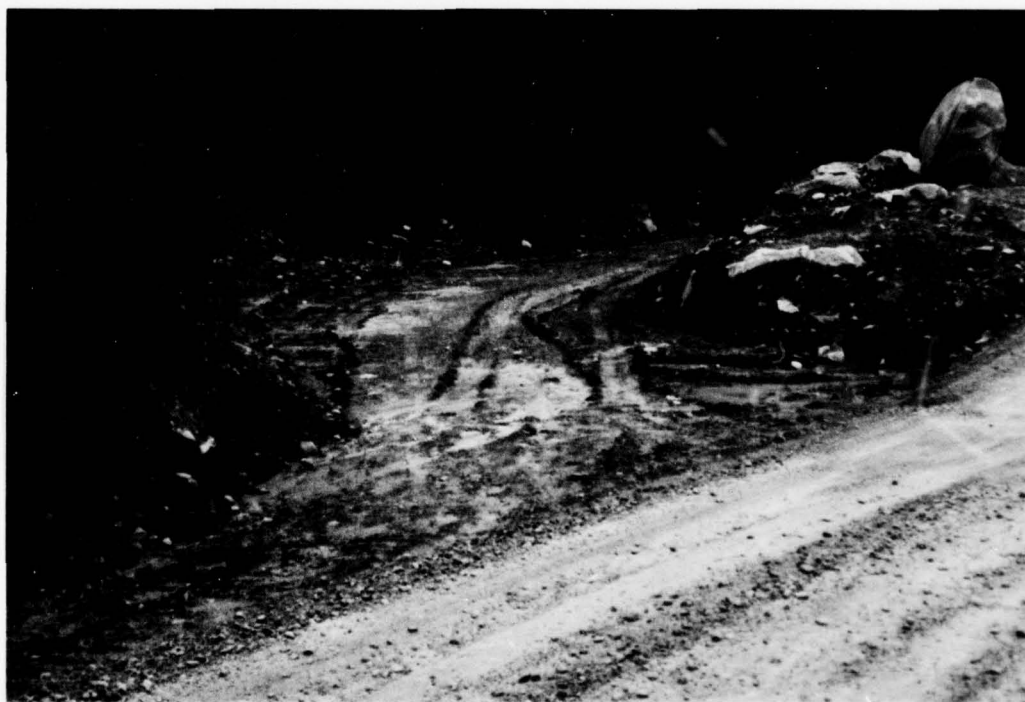
16) DOWNSTREAM VIEW OF AUXILIARY EMERGENCY SPILLWAY AND CHANNEL
